4.1 GENERAL DESIGN CONSIDERATIONS

This chapter discusses structural, building envelope, and nonstructural building systems, and illustrates various types of wind-induced damage that affect them. It also presents six case studies. Numerous examples of best practices pertaining to new and existing hospitals are presented as recommended design guidelines. Incorporating those practices applicable to specific projects will result in greater wind-resistance reliability and will, therefore, decrease expenditures for repair of wind-damaged facilities, provide enhanced protection for occupants, and avoid disruption of critical services.

The recommendations presented in this manual are based on field observation research conducted on 25 hospitals that were struck by

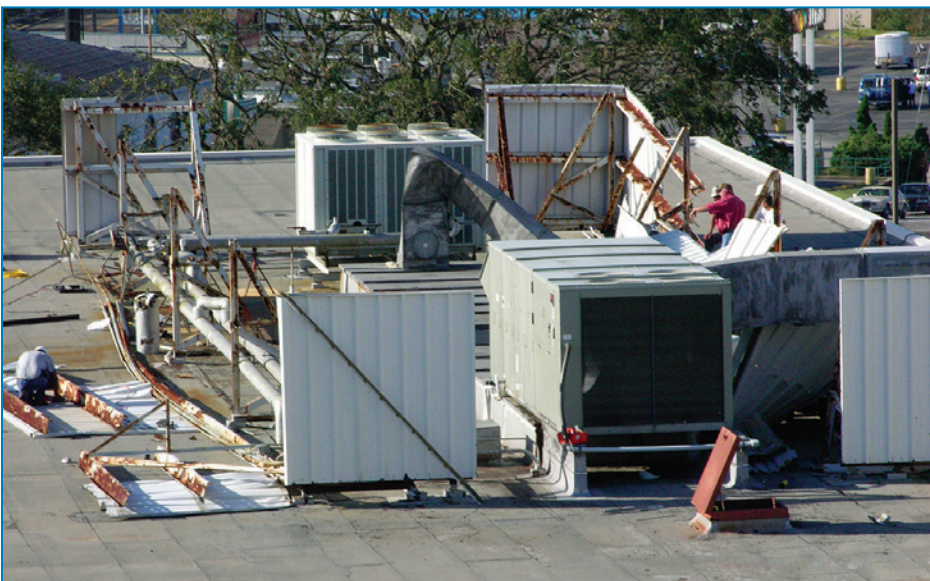
Figure 4-94:
Equipment screen panels, such as these blown away at a hospital, can break glazing, puncture roof membranes, and cause injury. Hurricane Ivan (Florida, 2004)

Equipment screens: Screens around rooftop equipment are frequently blown away (see Figure 4-94). Screens should be designed to resist the wind load derived from ASCE 7. Since the effect of screens on equipment wind loads is unknown, the equipment attachment behind the screens should be designed to resist the design load.

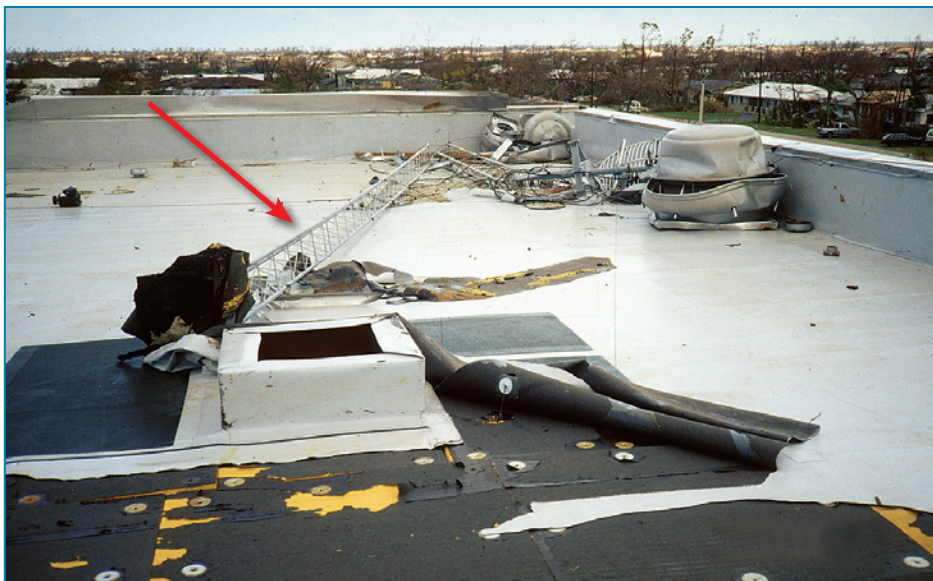
Figure 4-95:

Collapse of both large and small communication towers at hospitals is quite common during high-wind events (see Figures 4-15 and 4-95). These failures often result in complete loss of communication capabilities. In addition to the disruption of communications, collapsed towers can puncture roof membranes and allow water leakage into the hospital, unless the roof system incorporated a secondary membrane (as discussed in Section 4.3.3.8). At the tower shown in Figure 4-95, the anchor bolts were pulled out of the deck, which resulted in a progressive peeling of the fully adhered single-ply roof membrane. Tower collapse can also injure or kill people.

The collapse of the antenna tower caused progressive peeling of the roof membrane. Also note that the exhaust fan blew off the curb, but the high parapet kept it from blowing off the roof. Hurricane Andrew (Florida, 1992)

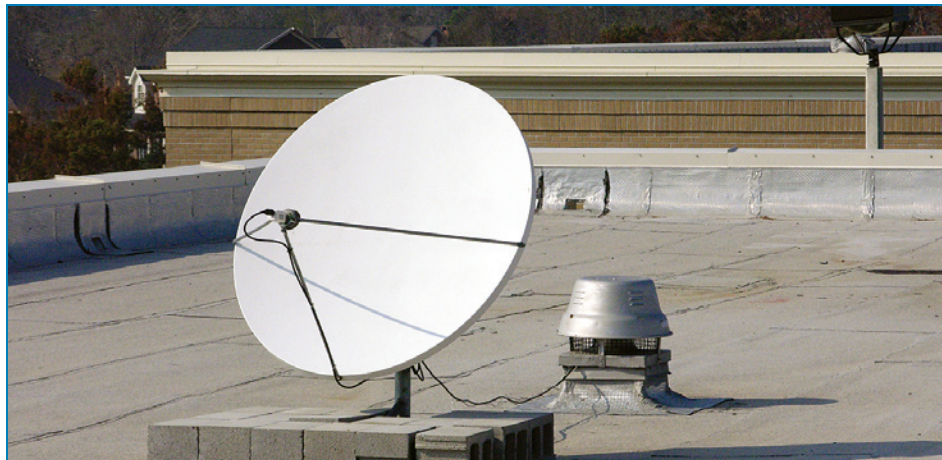
Figure 4-96:
Common anchoring
method for satellite
dish. Hurricane Ivan
(Florida, 2004)

Satellite dishes: For the satellite dish shown in Figure 4-96, the dish mast was anchored to a large metal pan that rested on the roof membrane. CMU was placed on the pan to provide overturning resistance. This anchorage method should only be used where calculations demonstrate that it provides sufficient resistance. In this case the wind approached the satellite dish in such a way that it experienced very little wind pressure. In hurricane-prone regions, use of this anchorage method is not recommended (see Figures 4-83 and 4-97).

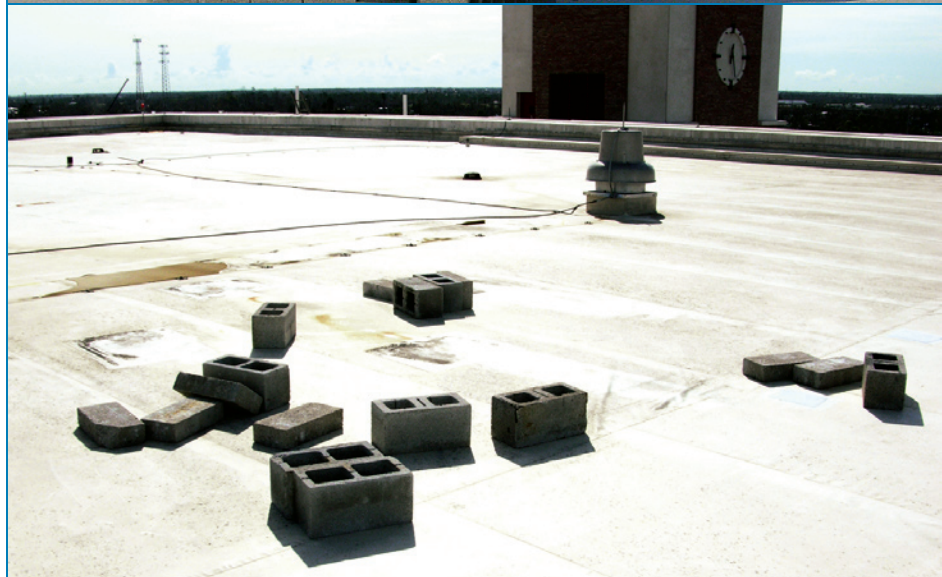
Figure 4-97:
A satellite dish
anchored similarly to
that shown in Figure
4-96 was blown off
this five-story building.
Hurricane Charley
(Florida, 2004)

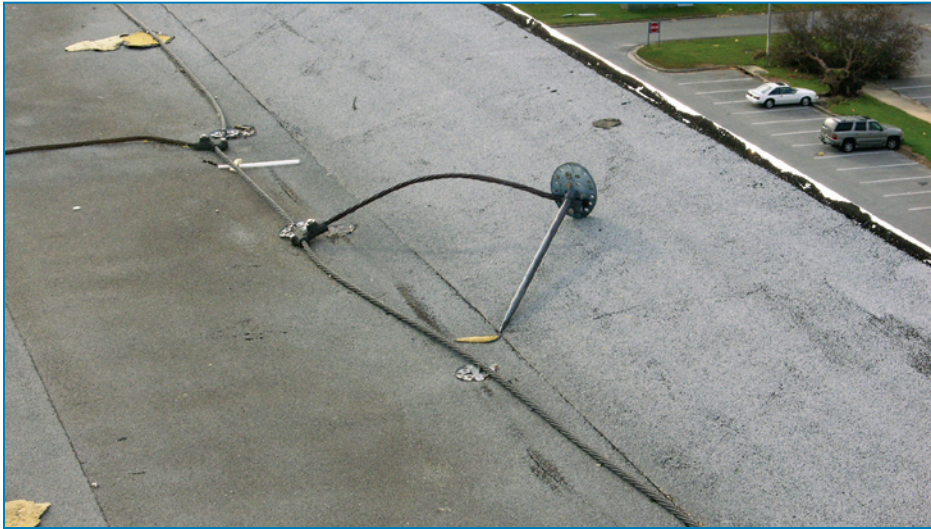
Lightning protection systems frequently become disconnected from rooftops during hurricanes. Displaced LPS components can puncture and tear roof coverings, thus allowing water to leak into buildings (see Figures 4-98 and 4-99). Prolonged and repeated slashing of the roof membrane by loose conductors (“cables”) and puncturing by air terminals (“lightning rods”) can result in lifting and peeling of the membrane. Also, when displaced, the LPS is no longer capable of providing lightning protection in the vicinity of the displaced conductors and air terminals.

Figure 4-98: An air terminal debonded from the hospital's roof. Displaced air terminals can puncture tough membranes, such as this modified bitumen membrane. Hurricane Ivan (Florida, 2004)

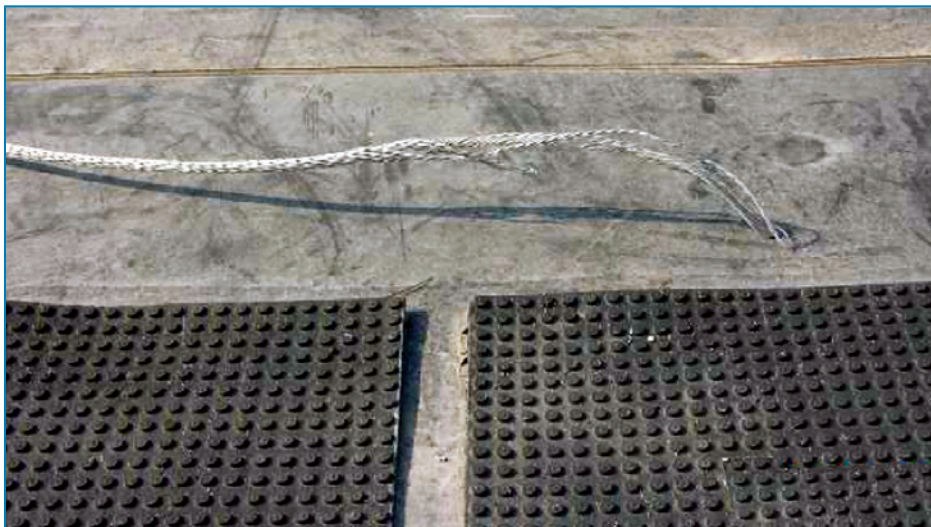
Figure 4-99: View of an end of a conductor at a hospital that became disconnected. Hurricane Katrina (Mississippi, 2005)

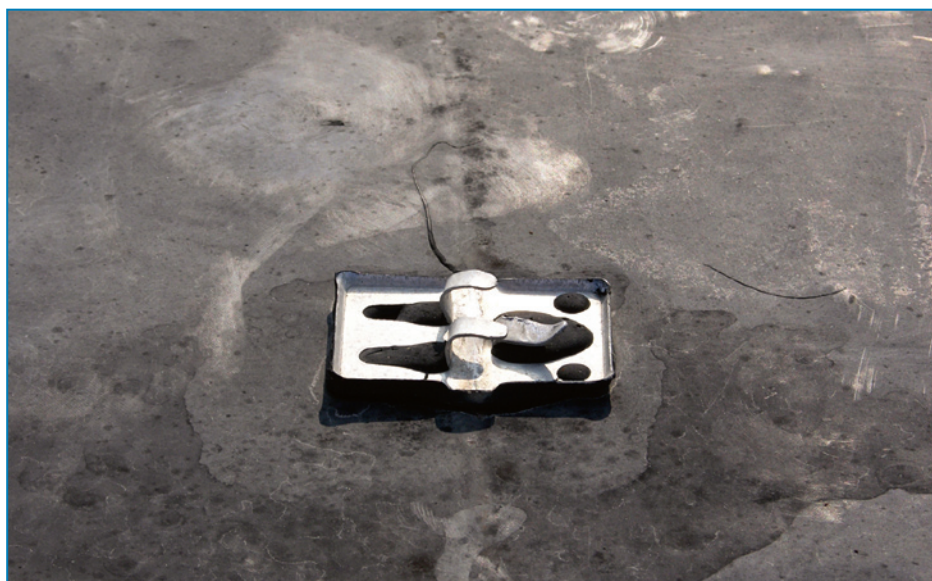
Lightning protection standards such as NFPA 780 and UL 96A provide inadequate guidance for attaching LPS to rooftops in hurricane-prone regions, as are those recommendations typically provided by LPS and roofing material manufacturers. LPS conductors are typically attached to the roof at 3-foot intervals. The conductors are flexible, and when they are exposed to high winds, the conductors exert dynamic loads on the conductor connectors (“clips”). Guidance for calculating the dynamic loads does not exist. LPS conductor connectors typically have prongs to anchor the conductor. When the connector is well-attached to the roof surface, during high winds the conductor frequently bends back the malleable connector prongs (see Figure 4-100). Conductor connectors have also debonded from roof surfaces during high winds. Based on observations after Hurricane Katrina and other hurricanes, it is apparent that pronged conductor connectors typically have not provided reliable attachment.

Figure 4-100:
The conductor deformed the prongs under wind pressure, and pulled away from the connector. Hurricane Katrina (Mississippi, 2005)

Parapet attachment: When the parapet is 12-inches high or greater, it is recommended that the air terminal base plates and conductor connectors be mechanically attached with #12 screws that have minimum 1¼-inch embedment into the inside face of the parapet nailer and are properly sealed for watertight protection. Instead of conductor connectors that have prongs, it is recommended that mechanically attached looped connectors be installed (see Figure 4-101).

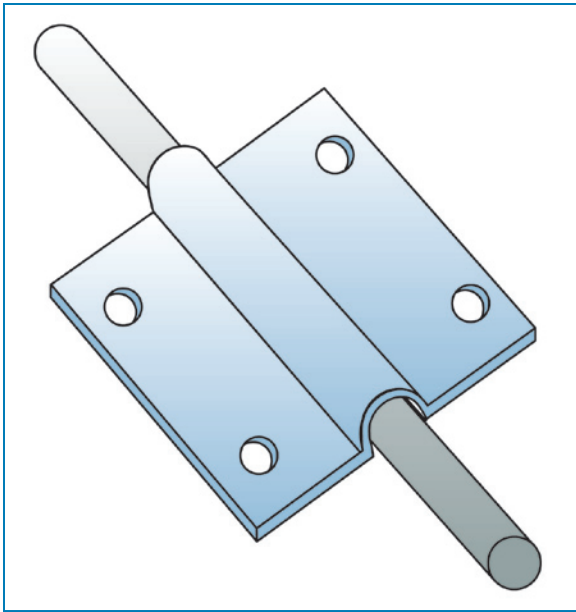
Figure 4-103:
Adhesively attached conductor connector
that does not use prongs

As an option to securing the conductors with stripping plies, conductor connectors that do not rely on prongs could be used (such as the one shown in Figure 4-103). However, the magnitude of the dynamic loads induced by the conductor is unknown, and there

is a lack of data on the resistance provided by adhesively-attached connectors. For this reason, attachment with stripping plies is the preferred option, because the plies shield the conductor from the wind. If adhesive-applied conductor connectors are used, it is recommended that they be spaced more closely than the 3-foot spacing required by NFPA 780 and UL 96A. Depending on wind loads, a spacing of 6 to 12 inches on center may be needed in the corner regions of the roof, with a spacing of 12 to 18 inches on center at roof perimeters (see ASCE 7 for the size of corner regions).

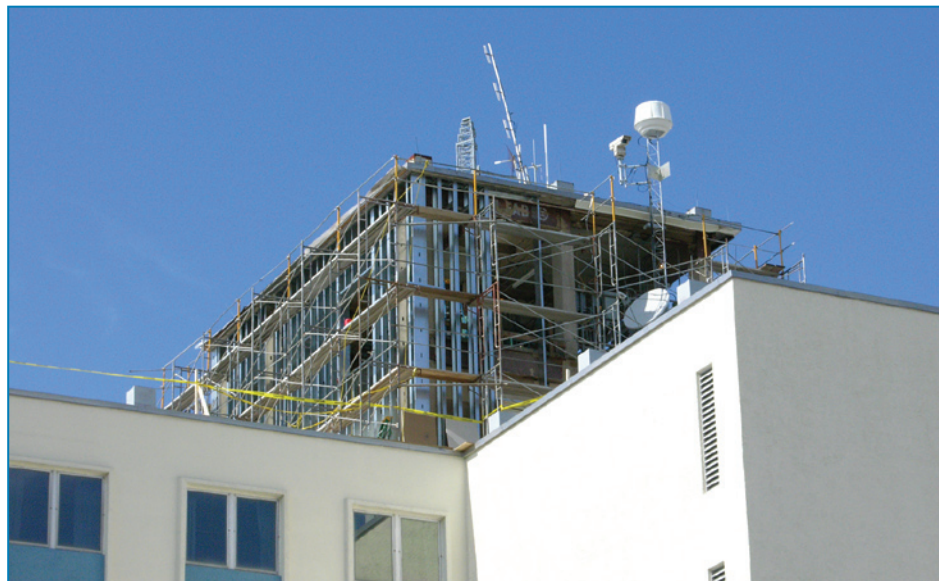
The hospital sustained damage to the elevator penthouse, roof covering, and roof-mounted equipment. Many of the metal panels on the elevator penthouse of the North Tower that were blown off during Hurricane Frances (Figure 4-106) tore the roof membrane on the tower roof as well as on lower roofs. Mechanical equipment was damaged on the tower roof (Figure 4-107) and on lower roofs. The LPS was displaced on the tower roof (Figure 4-108) and on lower roofs. Unlike the windows on the first floor that were protected with shutters, the upper-level windows were not protected. However, none of them were broken, although a significant amount of water leaked through many of these windows. The second hurricane (Jeanne) caused additional water infiltration and interrupted reconstruction work.

Figure 4-106:
View of the
reconstruction of the
damaged walls at the
elevator penthouse

Loss of the elevator penthouse panels allowed water infiltration into the elevator equipment room, which destroyed the control equipment. Water also leaked into the nursing floors, which made it necessary to evacuate the patients. Because of significant interior water damage and lack of vertical transportation, many patients had to be evacuated by helicopter.

As dramatically illustrated at this hospital, water infiltration and the lack of elevator service can take portions of the hospital offline for several weeks. Rather than simply replace the elevator penthouse walls, an engineer was retained to design a more wind-resistant wall covering system. The new design for the elevator penthouse wall system was developed and new elevator control equipment was installed, bringing the 5th floor back online about 4 weeks after the first hurricane struck. The remaining floors (2, 3, 4, and 6) were brought back online at a rate of about one floor every 2 weeks after the 5th floor was reopened. It cost \$3,733,233 to repair the North Tower. In addition to this expenditure, the hospital lost a significant amount of patient revenue.

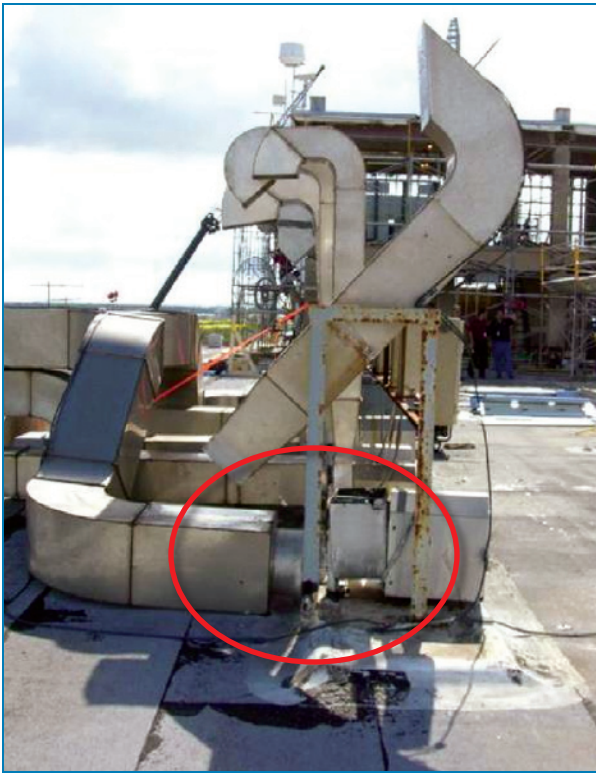
Figure 4-107:
Damaged HVAC equipment. Work is underway on the elevator penthouse beyond.

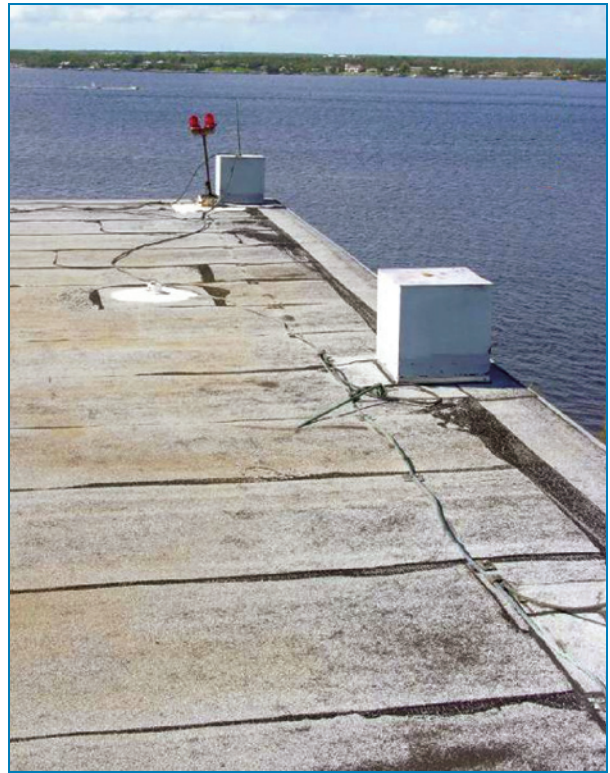
Figure 4-108:
Displaced LPS

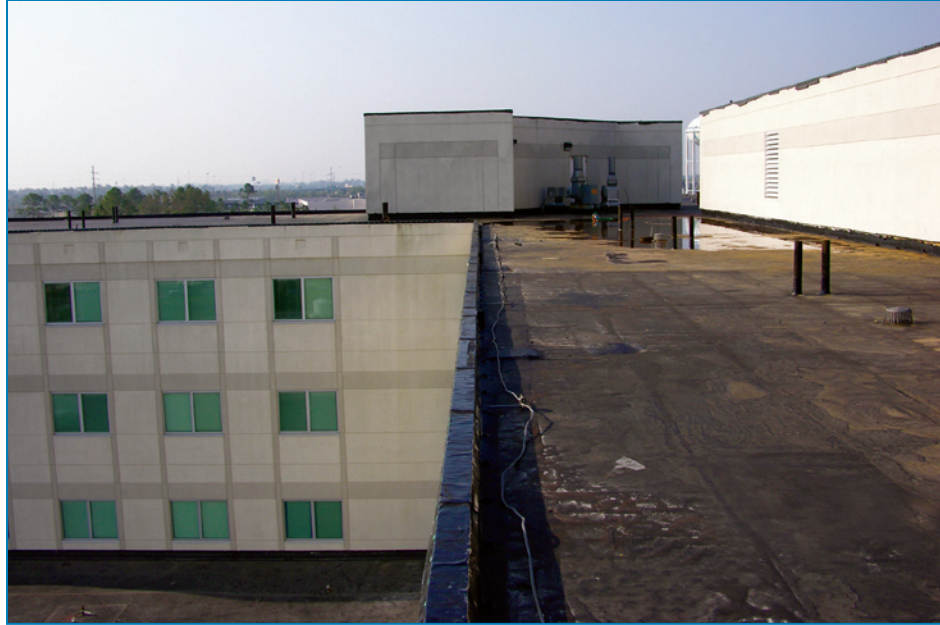
Figure 4-109:

The roof on this 5-year old hospital blew off. Water leaked into the patient floor below. The floor was taken out of service for more than a month. Hurricane Katrina (Mississippi, 2005)

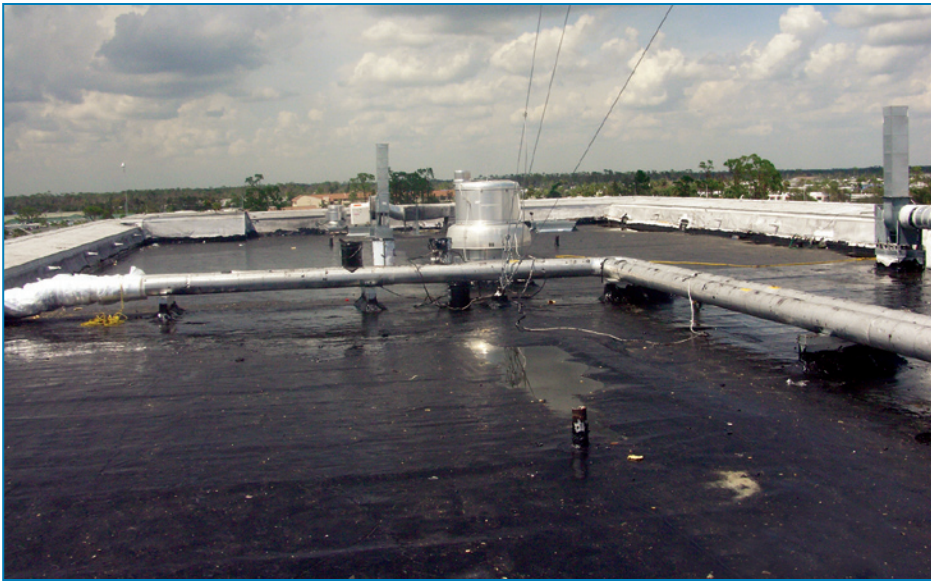
Figure 4-110 may identify weakness of the roof membrane and/or rooftop equipment. Replacing weak components before a hurricane is much cheaper than replacing them and repairing consequential damages after a storm, and proactive work avoids the loss of use while repairs are made.

Figure 4-110:
The roof membrane and some of the rooftop equipment blew off. Although the deck was cast-in-place concrete, water leaked into the patient floor below. Hurricane Charley (Florida, 2004)

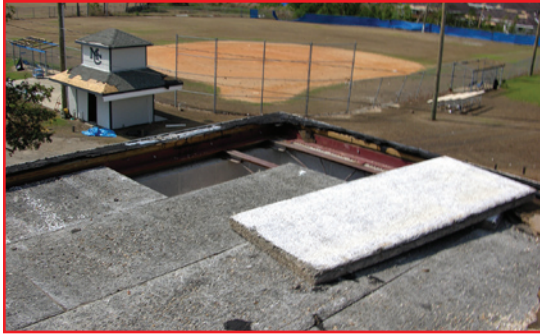
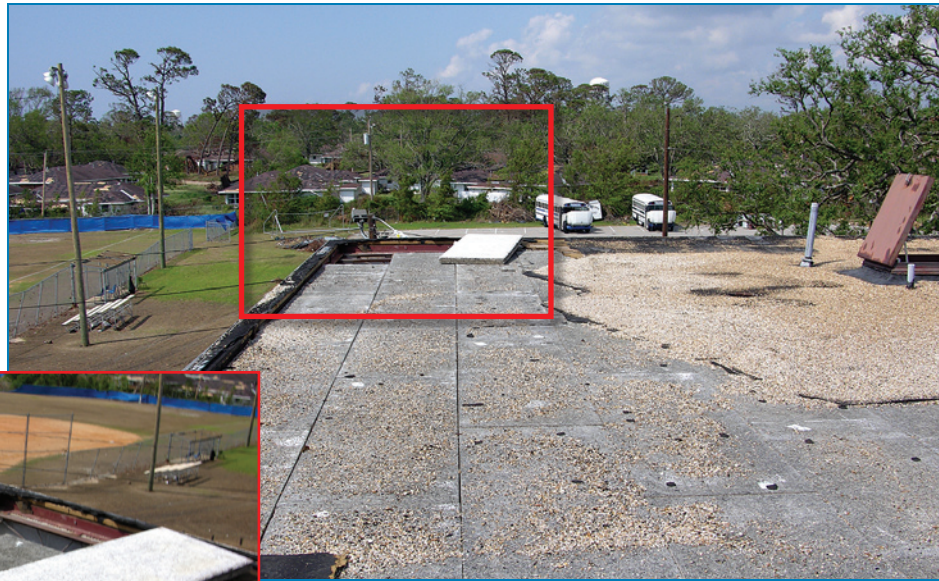
Figure 4-111:

As discussed in Section 4.1.4.1, roof decks on many facilities designed prior to the 1982 edition of the SBC and UBC and the 1987 edition of the NBC are very susceptible to failure. Poorly attached decks that are not upgraded are susceptible to blow-off, as shown in Figures 4-111 and 4-132. Decks constructed of cementitious wood-fiber, gypsum, and lightweight insulating concrete over form boards were commonly used on buildings built in the 1950s and 1960s. In that era, these types of decks, as well as precast concrete decks, typically had very limited uplift resistance due to weak connections to the support structure. Steel deck attachment is frequently not adequate because of an inadequate number of welds, or welds of poor quality. Older buildings with overhangs are particularly susceptible to blow-off, as shown in Figure 4-112, because older codes provided inadequate uplift criteria.

The built-up roof blew off after one of the cementitious wood-fiber deck panels detached from the joists. Hurricane Katrina (Mississippi, 2005)

A vulnerability assessment of the roof deck should include evaluating the existing deck attachment, spot checking the structural integrity of the deck (including the underside, if possible), and evaluating the integrity of the beams/joists. If the deck attachment is significantly overstressed under current design wind conditions or the deck integrity is compromised, the deck should be replaced or strengthened as needed. The evaluation should be conducted by an investigator experienced with the type of deck used on the building.

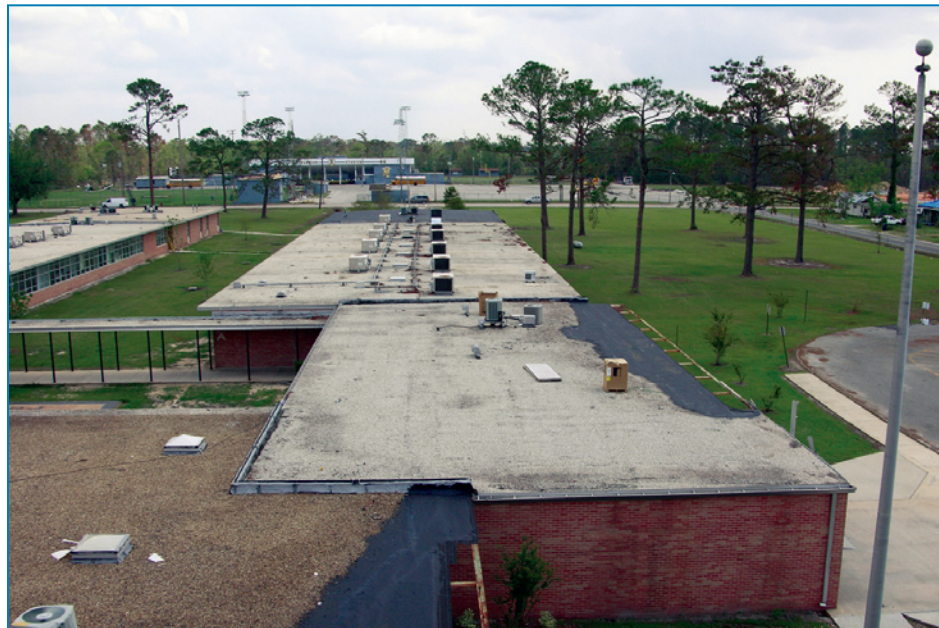
Figure 4-112:

The cementitious wood-fiber deck panels detached from the joists along the overhangs and caused the built-up membranes to lift and peel. Hurricane Katrina (Mississippi, 2005)

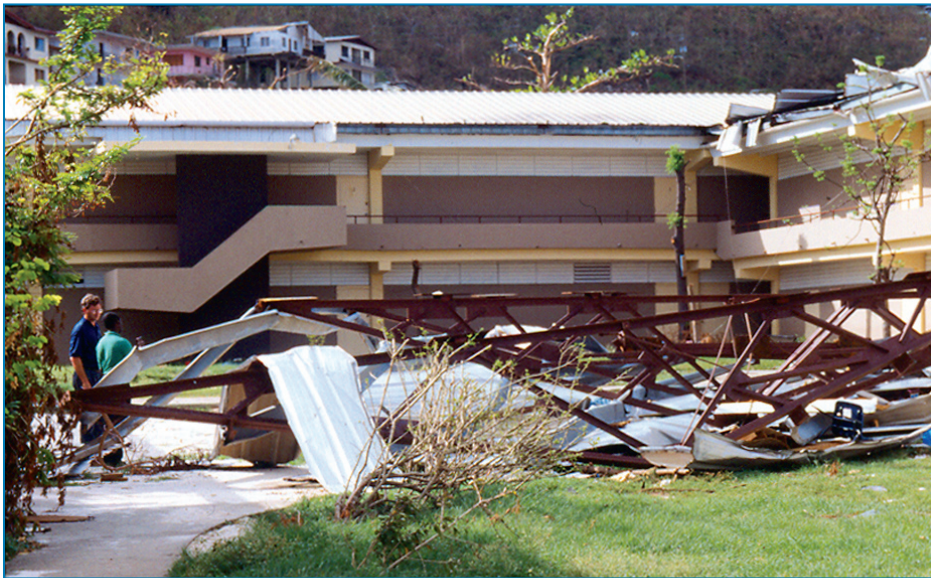
Figure 4-113:
The steel truss superstructure installed as part of a steep-slope conversion blew away because of inadequate attachment. Hurricane Marilyn (U.S. Virgin Islands, 1995)

If a low-slope roof is converted to a steep-slope roof, the new support structure should be engineered and constructed to resist the wind loads and avoid the kind of damage shown in Figure 4-113.

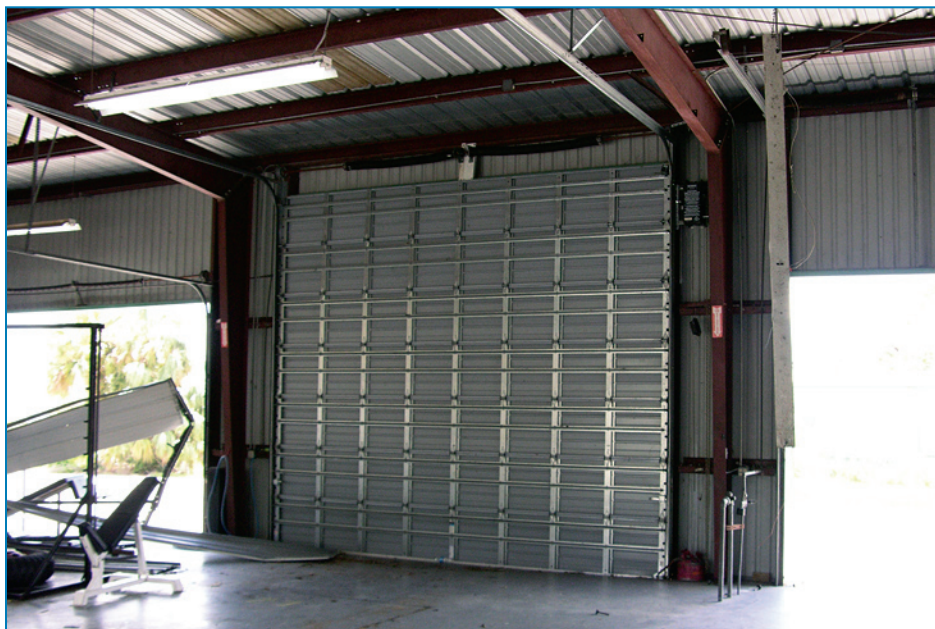
Figure 4-114:

If a facility has more than one sectional or rolling door, all doors should be replaced, rather than just replacing one of the doors. The building shown in Figure 4-114 had six sectional doors. One door had been replaced before a hurricane. It performed very well, but three of the older doors were blown away and two of the older doors remained in place but had some wind damage.

The new door in the center performed very well, but the older doors on either side of it were blown away. Hurricane Charley (Florida, 2004)

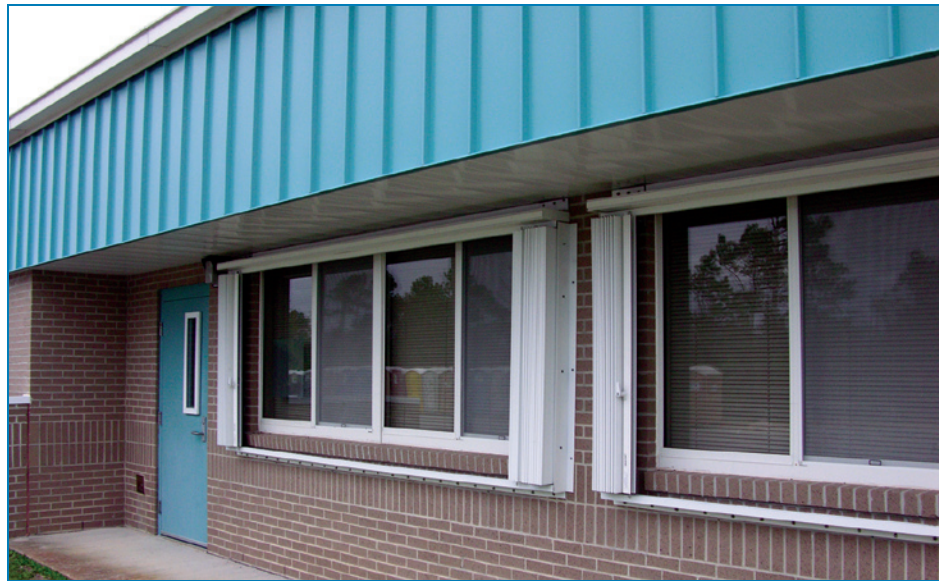
Figure 4-117:
A metal panel shutter.
Hurricane Georges
(Puerto Rico, 1998)

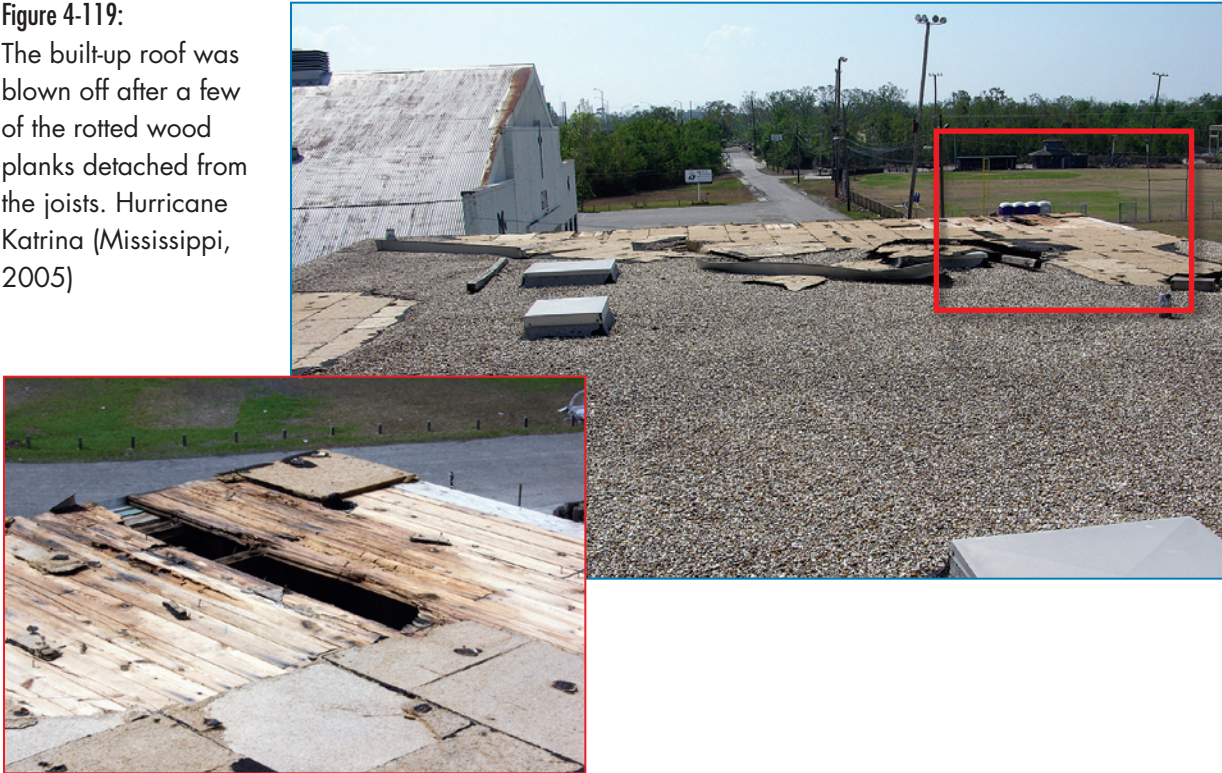
Figure 4-119:

The built-up roof was blown off after a few of the rotted wood planks detached from the joists. Hurricane Katrina (Mississippi, 2005)

When planning the replacement of a roof covering, it is recommended that all existing roof covering be removed down to the deck rather than simply re-covering the roof. Tearing off the covering provides an opportunity to evaluate the structural integrity of the deck and correct deck attachment and other problems. For example, if a roof deck was deteriorated due to roof leakage (see Figure 4-119), the deterioration would likely not be identified if the roof was simply re-covered. By tearing off

down to the deck, deteriorated decking like that shown in Figure 4-119 can be found and replaced. In addition, it is recommended that the attachment of the wood nailers at the top of parapets and roof edges be evaluated and strengthened where needed, to avoid blow-off and progressive lifting and peeling of the new roof membrane (see Figure 4-126).

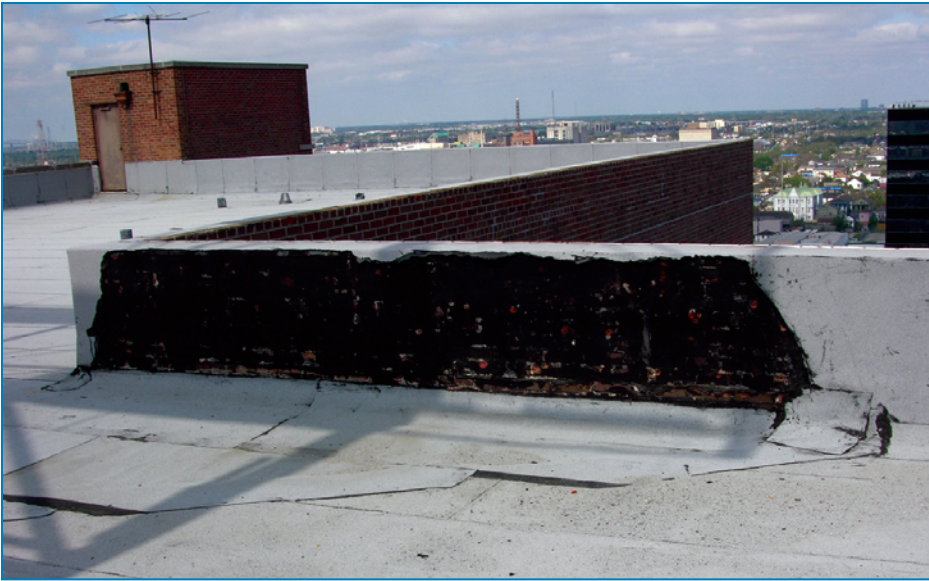
Figure 4-120:
Failed base flashing
adhered directly to
the brick parapet.
Hurricane Katrina
(Louisiana, 2005)

If the roof has a parapet, it is recommended that the inside of the parapet be properly prepared to receive the new base flashing. In many instances, it is prudent to re-skin the parapet with sheathing to provide a suitable substrate. Base flashing should not be applied directly to brick parapets because they have irregular surfaces that inhibit good bonding of the base flashing to the brick (see Figure 4-120). Also, if moisture drives into the wall from the exterior side of the parapet with base flashing attached directly to brick, the base flashing can inhibit drying of the wall. Therefore, rather than totally sealing the parapet with membrane base flashing, the upper portion of the brick can be protected by metal panels (as shown in Figure 4-79), which permit drying of the brick.

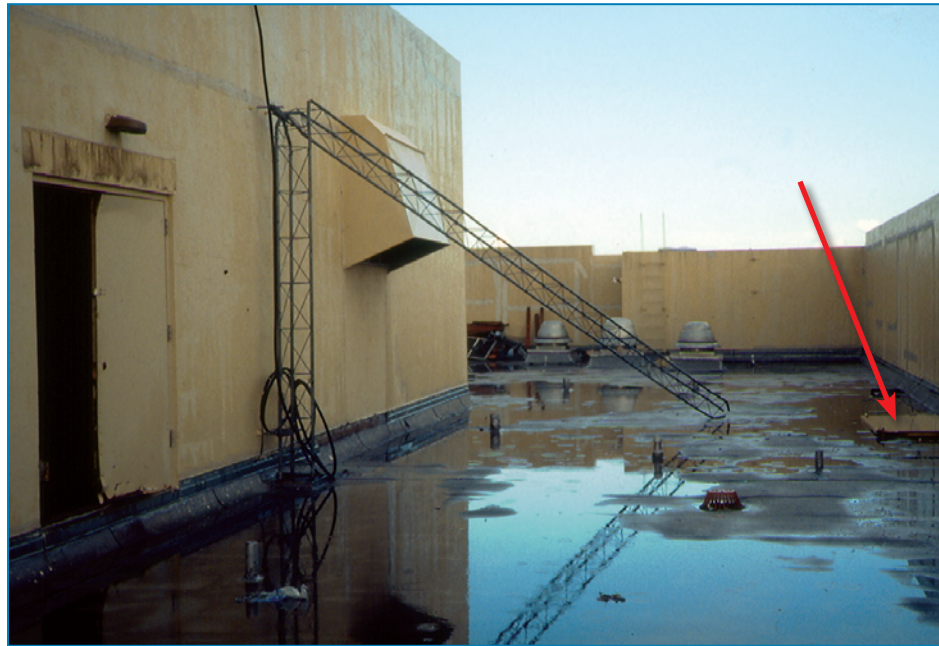
Figure 4-121:

Antenna collapse is very common. Besides loss of communications, collapsed masts can puncture roof membranes or cause other building damage as shown in Figure 4-121. This case also demonstrates the benefits of a high parapet. Although the roof still experienced high winds that blew off this penthouse door, the parapet prevented the door from blowing off the roof (red arrow in Figure 4-121).

The antenna at this hospital collapsed and was whipped back and forth across the roof membrane. Hurricane Andrew (Florida, 1992)

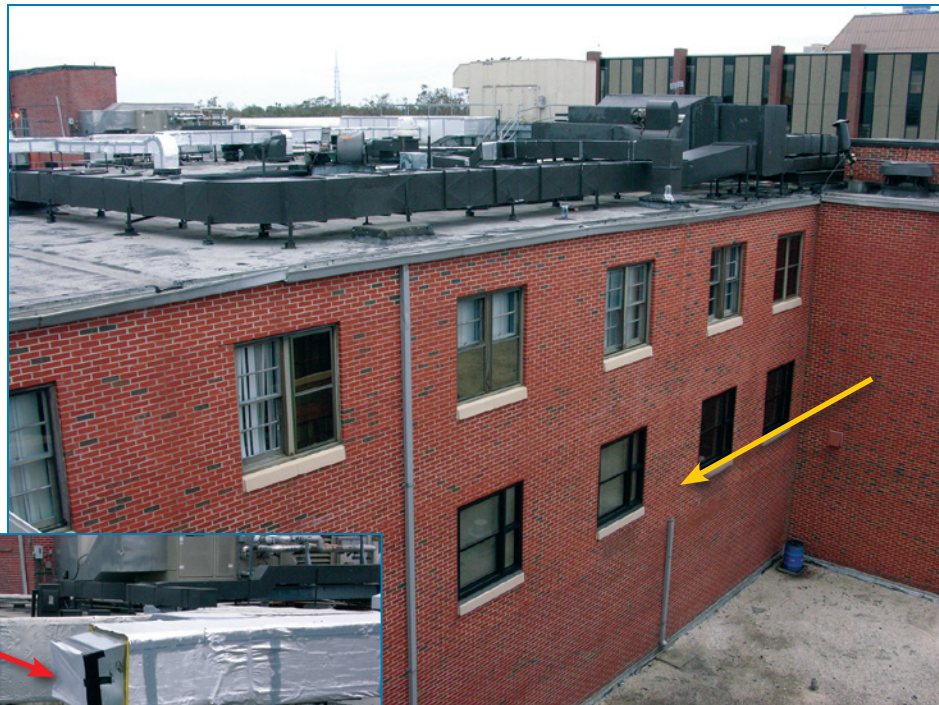
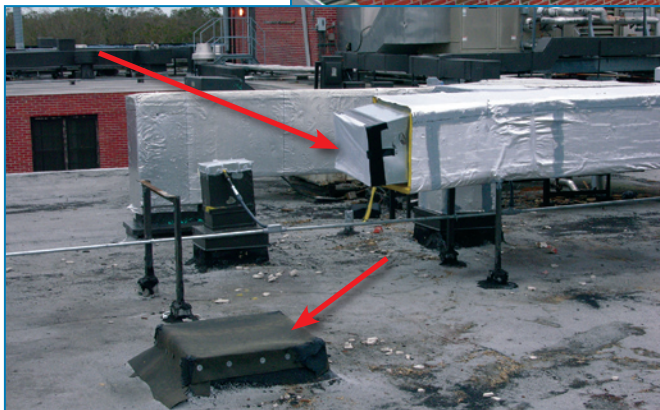
Figure 4-124:

Water entered the hospital at damaged rooftop equipment (Figure 4-124), and at areas where the roof membrane blew off (Figures 4-125 and 4-126) and where it was punctured. The roof failure shown in Figure 4-126 was caused by an inadequately attached edge nailer anchored to the brick wall. Failure of the nailer caused a progressive lifting and peeling of the roof membrane. Gutters and downspouts were blown off and a few windows were broken. The elevator penthouse roof was damaged at the psychiatric hospital (Figure 4-127) and the MOBs (Figure 4-125).

This hospital had a substantial amount of rooftop ductwork. Ductwork and fan units were damaged in several locations (see inset). Some of the windows in this area were also broken. Note the missing downspout (yellow arrow).

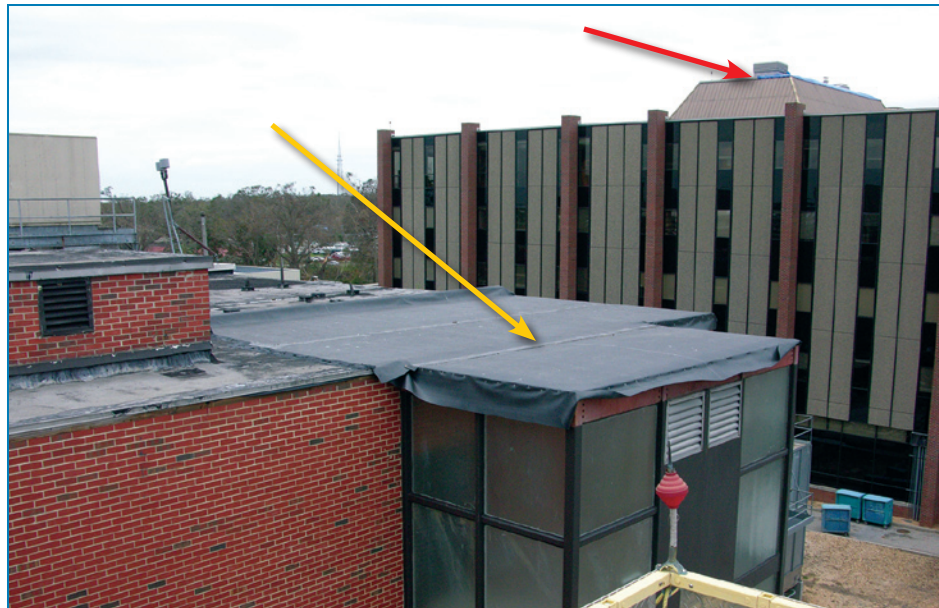
Figure 4-125:

The roof covering blew off – an emergency roof covering had been installed (yellow arrow). Note the damaged MOB penthouse beyond (red arrow).

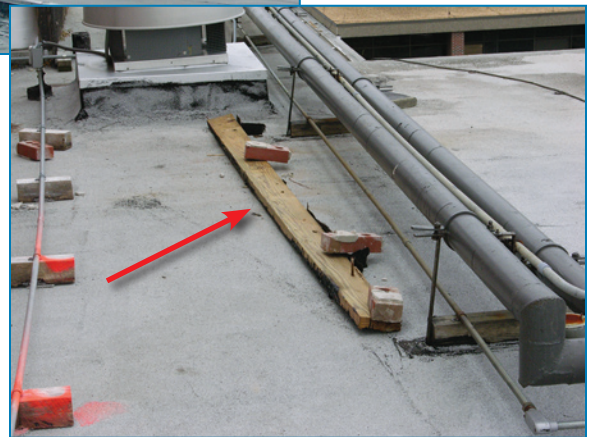
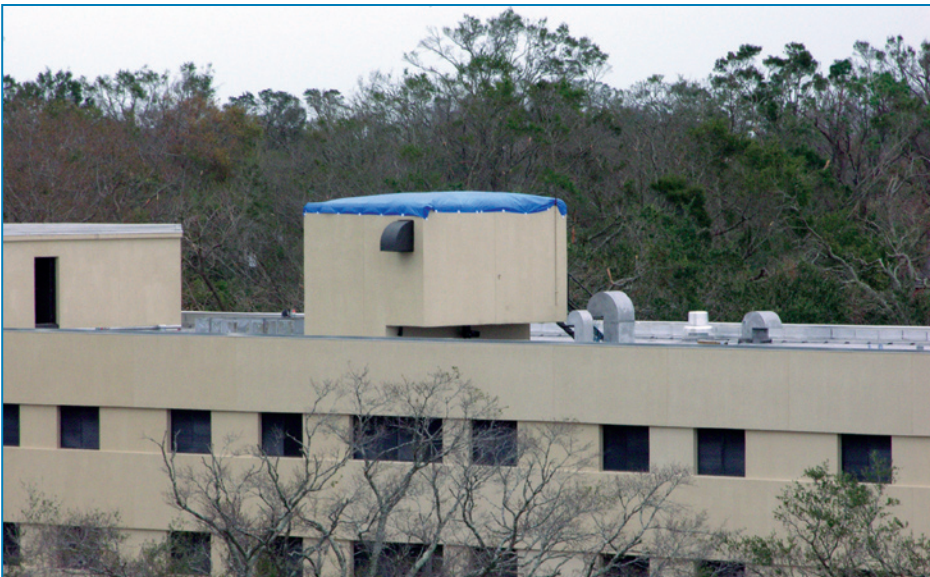
Figure 4-126:

The roof covering blew off – an emergency roof covering had been installed (blue arrow). The failure was caused by the inadequately attached nailer (see inset). The leaning mast at the right is a ladder (yellow arrow), with an extension for communications and an anemometer for the nearby heliport.

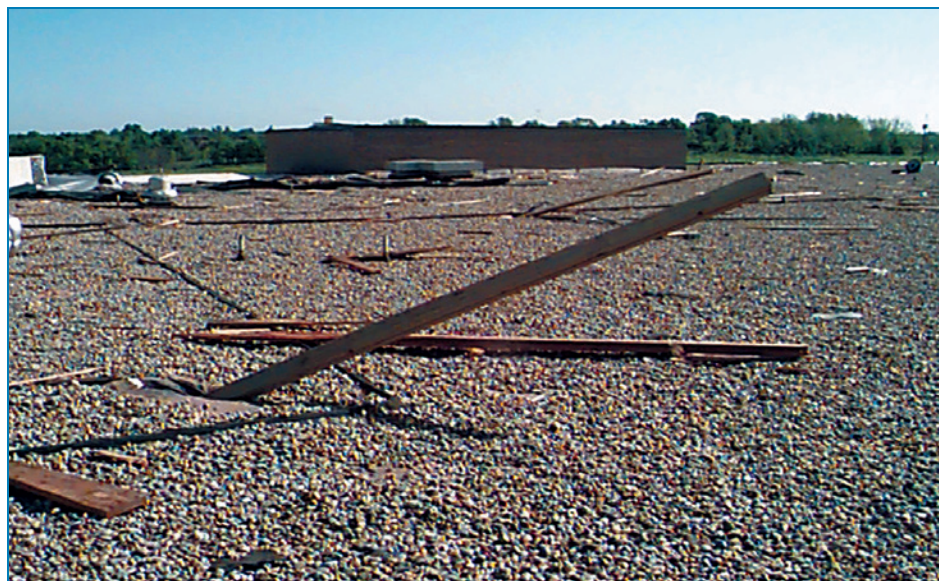
Strong and violent tornadoes can generate very powerful missiles. Experience shows that large and heavy objects, including vehicles, can be hurled into buildings at high speeds. The missile sticking out of the roof in the foreground of Figure 4-128 is a double 2-inch by 6-inch wood member. The portion sticking out of the roof is 13 feet long. It penetrated a ballasted ethylene propylene diene monomer (EPDM) membrane, approximately 3 inches of polyisocyanurate roof insulation, and the steel roof deck. The missile lying on the roof just beyond is a 2-inch by 10-inch by 16-foot long wood member.

Figure 4-128:
A violent tornado showered the roof with missiles. (Oklahoma, 1999)

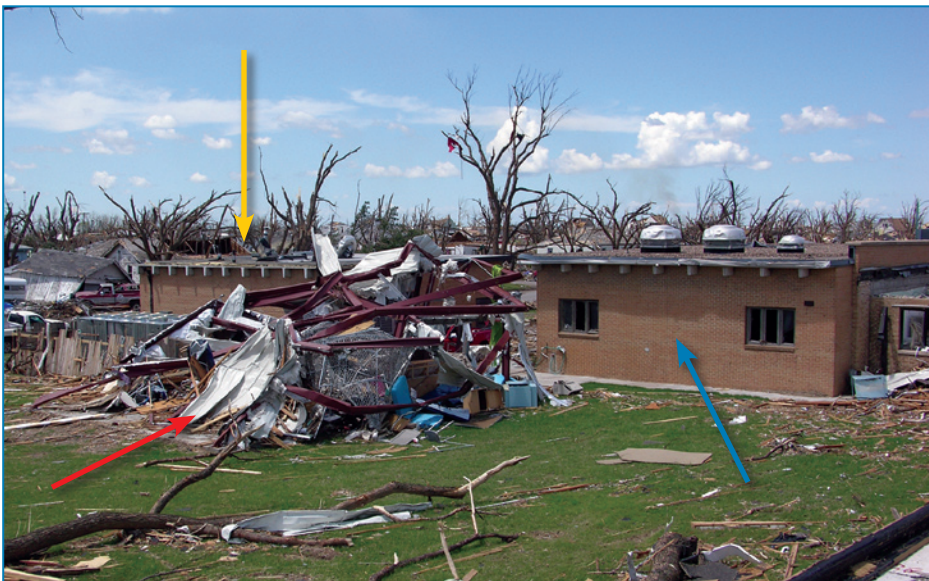
Figure 4-131:
The building housing the generator is shown by the yellow arrow. The kitchen facility is shown by the blue arrow. The red arrow shows the collapsed storage building.

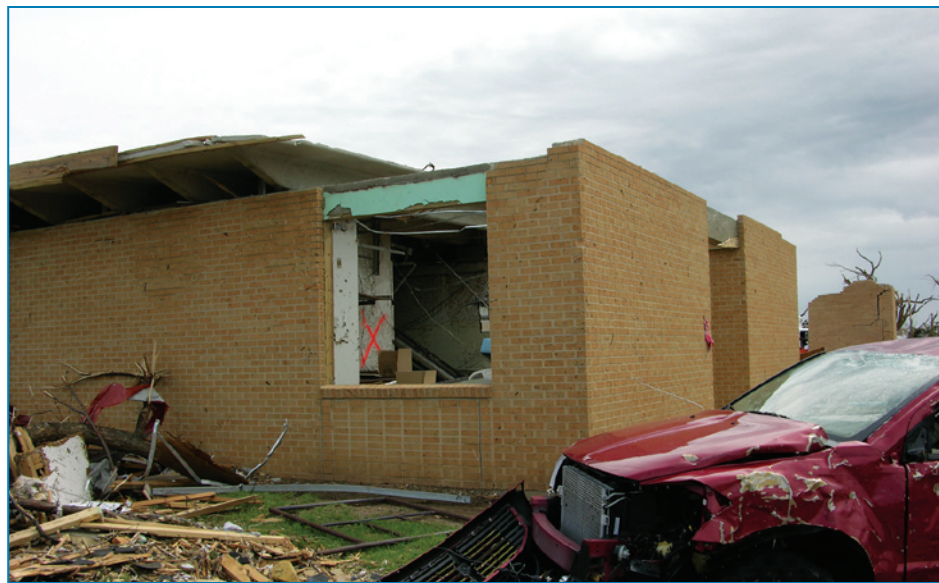
Figure 4-132:

One of the precast twin-tees from the original building blew off and flew approximately 80 feet (Figures 4-132 and 4-133). Where the tees rested on the bearing wall, steel bearing plates were embedded in the tee's beams, and bearing plates were embedded on top of the wall. At the wall in the foreground of Figure 4-132, the bearing plates had not been welded together. Hence, at that end of the tee, no uplift resistance was provided other than the tee's dead load. At the opposite bearing wall, the bearing plates were welded, but the bolts anchoring the plates to the wall failed in tension as the tee lifted. Both of the bearing plates had two small anchor bolts (about $\frac{3}{8}$ -inch diameter).

View of the end of the patient wing where the twin-tee blew off. Note the missing window.

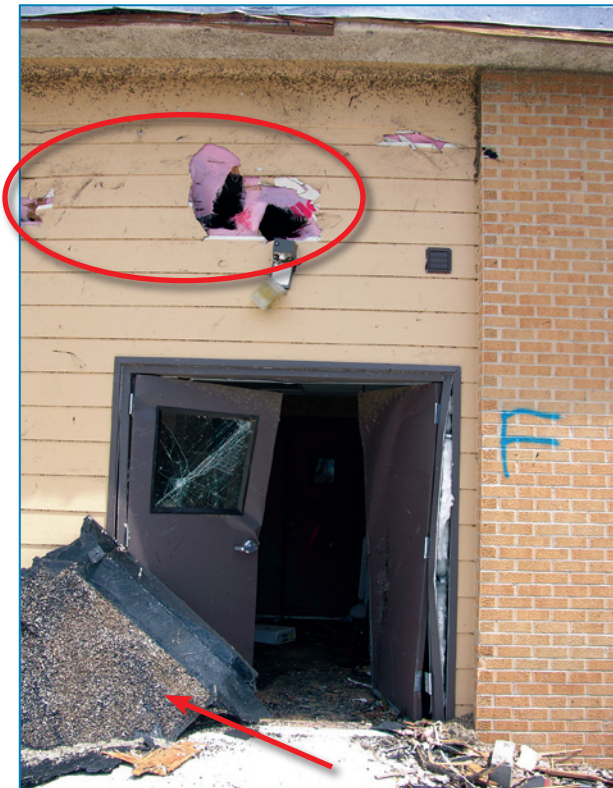
The hospital complex was struck with a very large number of missiles. Virtually all of the hospital's exterior glazing was broken. Figure 4-134 shows a damaged door at the kitchen facility. A piece of built-up roof (BUR) membrane struck the right door. Although the doors were out-swinging, the missile pushed the door inward. The lower right hinge was broken, and the right side of the door frame buckled and pulled from the rough opening. The laminated glass in the door was broken, but remained in place.

Figure 4-134:
The BUR missile (red arrow) struck the right door. Missiles also punctured the siding and wood sheathing (red oval).

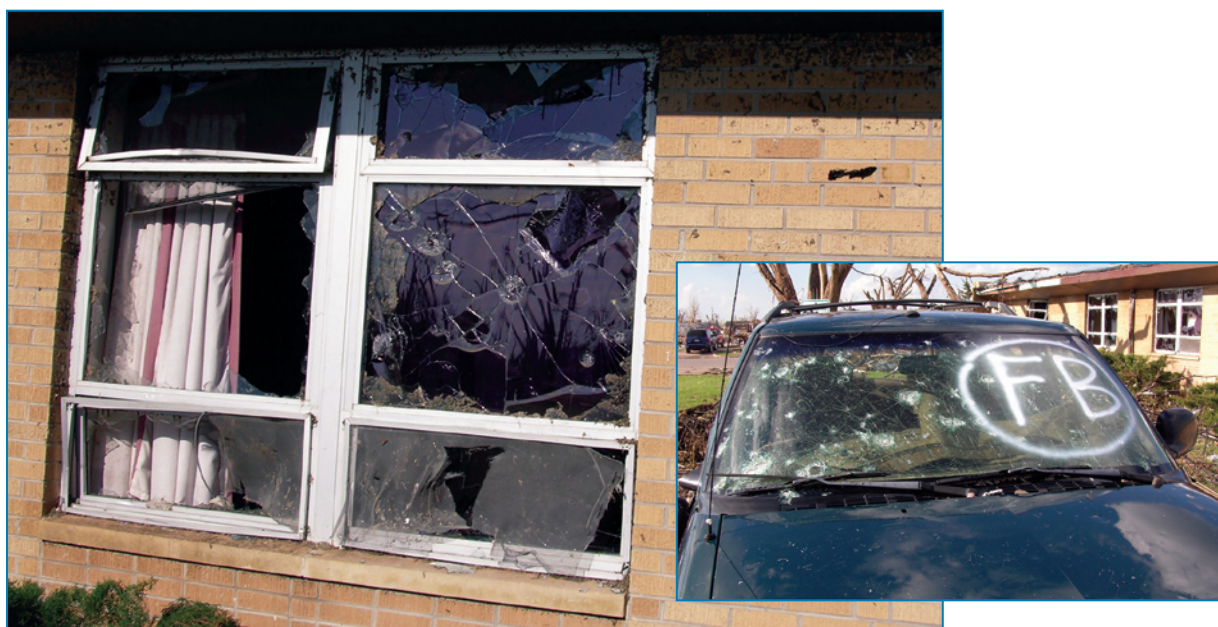
Figure 4-135:

Aggregate from the ballasted single-ply membrane roofs broke several windows (Figure 4-135), and pieces of the large aggregate (1½-inches in diameter, nominal) were found inside the building. Windows were also broken by 2x wood framing (Figure 4-136).

All six panes of glass were broken. The craters shown in the right center pane and at the vehicle windshield were caused by the large aggregate blown from the ballasted single-ply membranes.

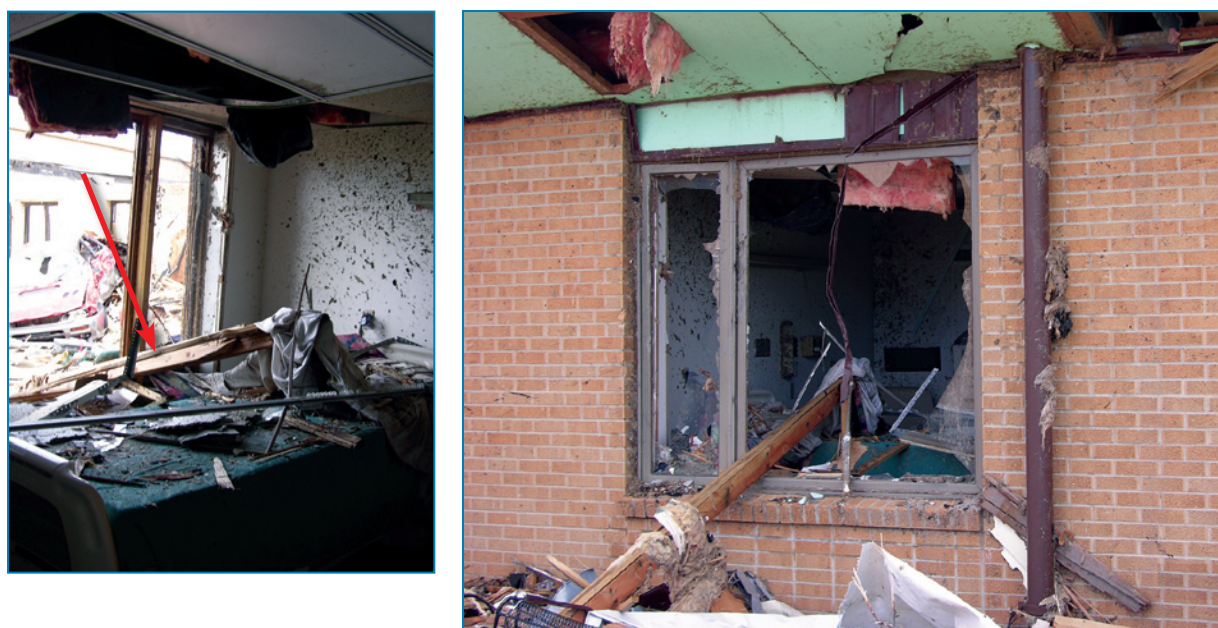
Figure 4-136:

A large missile (2x framing) penetrated this patient room. Note the debris on the bed in the inset (the arrow shows the same 2x missile).
